Renovating the Tab

ernacle

While the Salt Lake Tabernacle was closed to the public for two years, workers carried out an extensive renovation on the 140-year-old building.

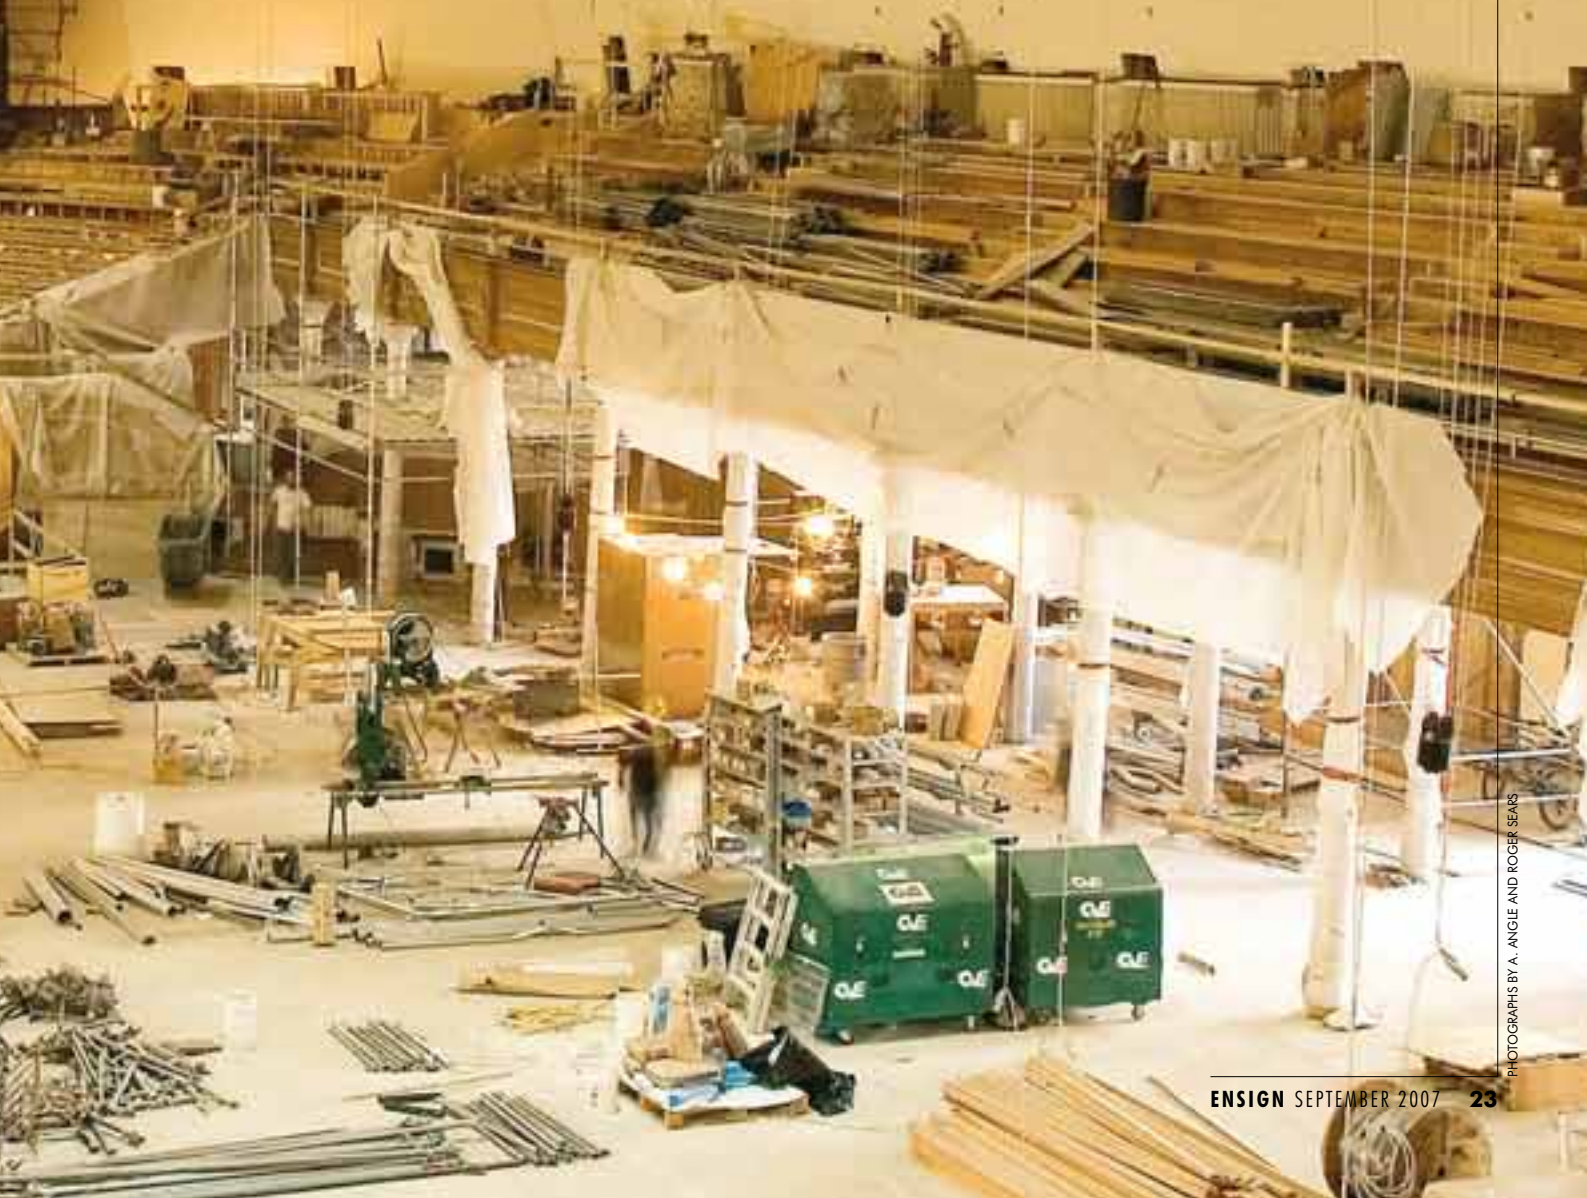
By June 2006 all of the pipes of the organ except those seen here had been removed for cleaning, and the slope of the floor in the balcony was being increased so all visitors would have a good view of the rostrum. The floor had been covered and the pillars wrapped for protection. The restoration of the ceiling had been finished.

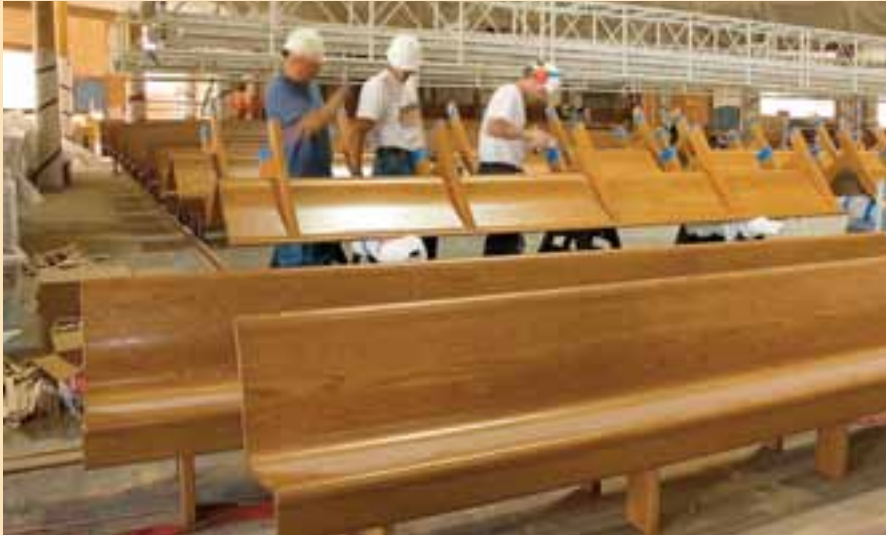
Above: Workers install solid white oak pews, which will replace most of the original soft pine ones. The original pews, painted by pioneer artisans to look like oak, were damaged and worn. Some will be permanently displayed.

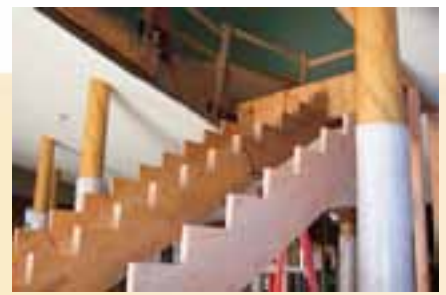
One of two new staircases added to the balcony makes six exits from the upper floor.

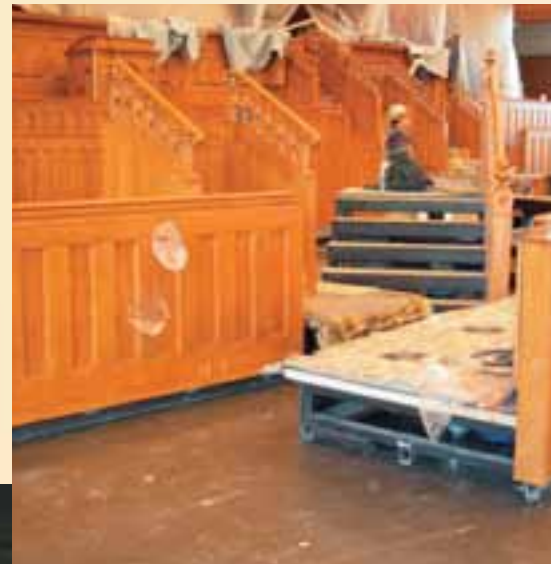
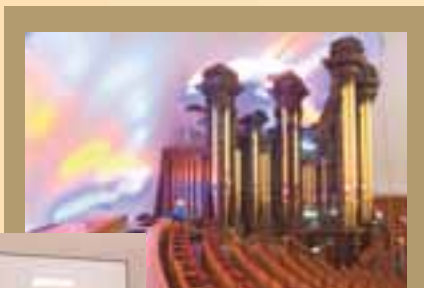
Audiovisual upgrades include a variety of new lighting effects. The inset shows one of two screens mounted on either side of the organ pipes. When not needed, the screens can be retracted behind the choir seats. State-of-the-art audio equipment has been installed, yet the famous acoustical properties of the Tabernacle have been preserved.

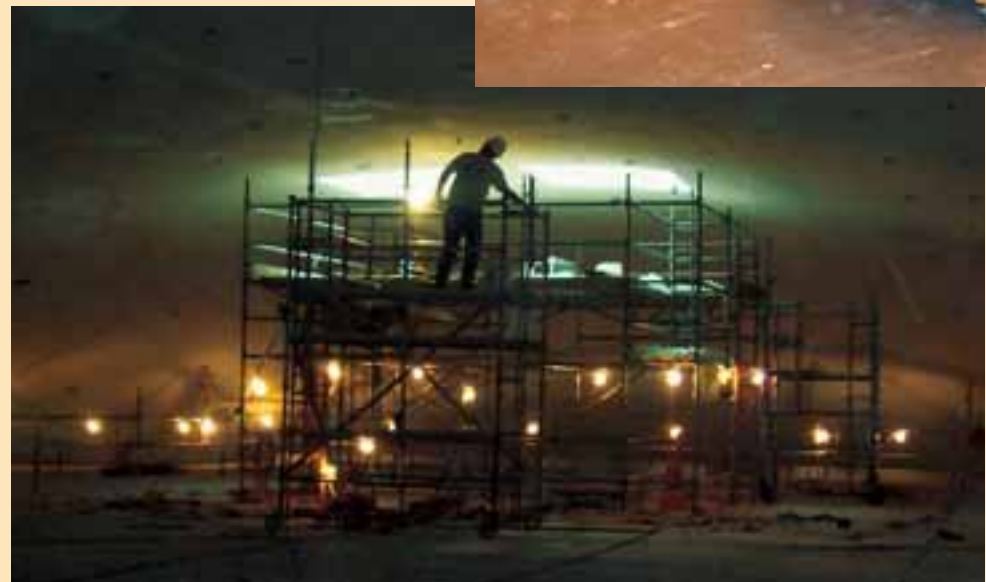
A worker stands atop scaffolding that is several stories high as he works on the restoration of the ceiling. Fourteen layers of paint were removed to reach the original plaster. After repairs were made, workers applied plaster that matched the properties of the historic plaster in both its content and acoustic properties. Care was taken to preserve the waviness of the original ceiling.

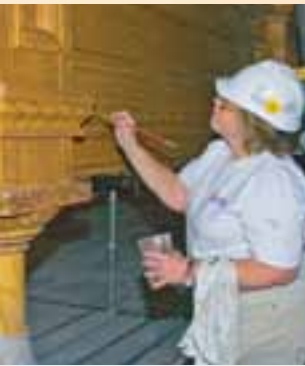
A skilled artist touches up the faux finish on the face of the balcony. Most of the faux graining on the walls and pillars of the Tabernacle needed to be repaired or replaced.

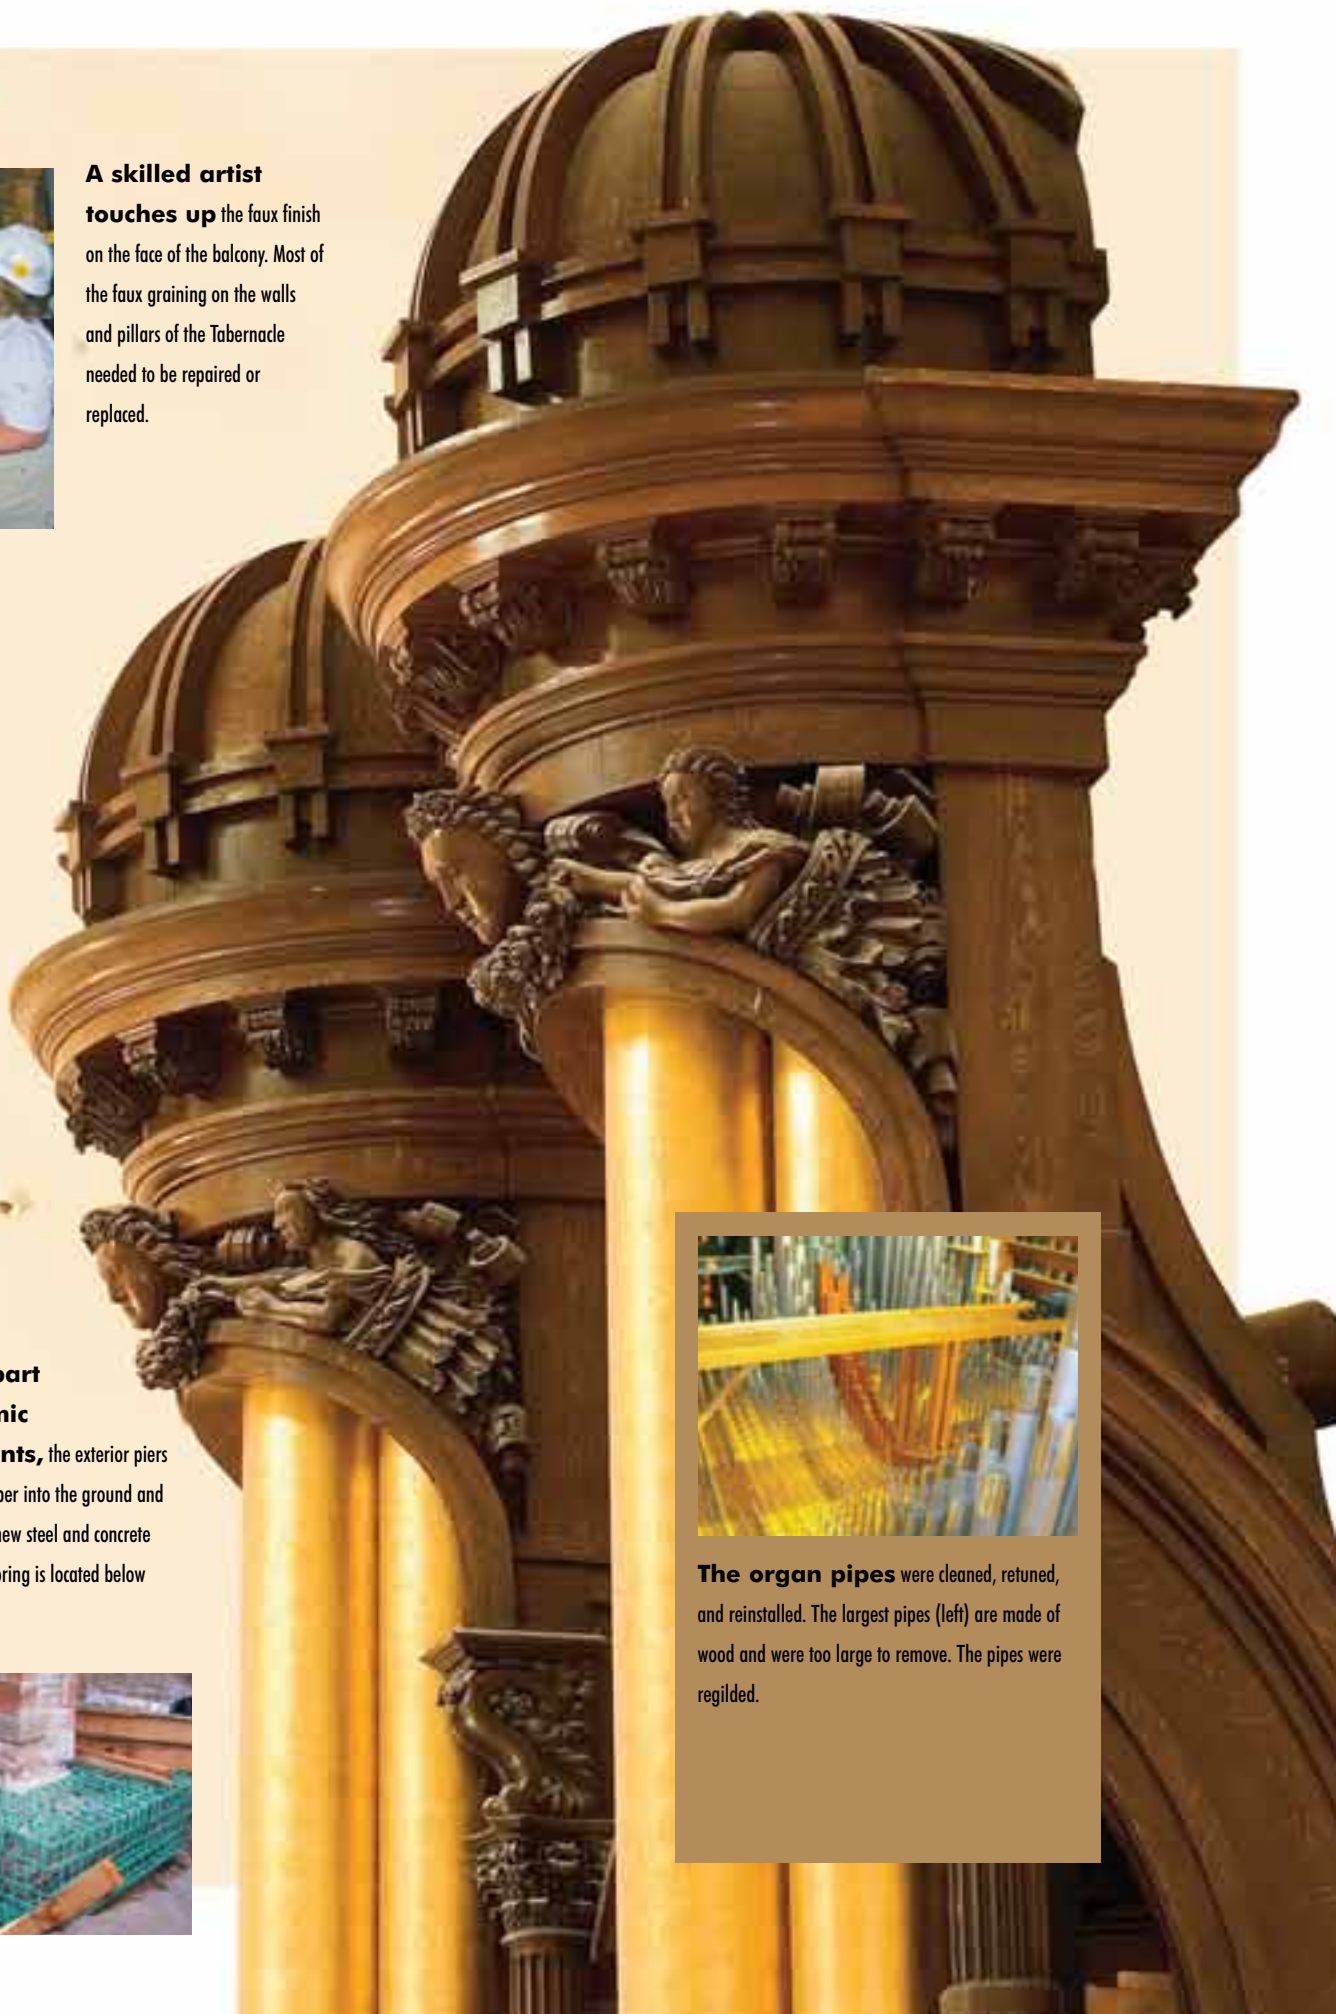
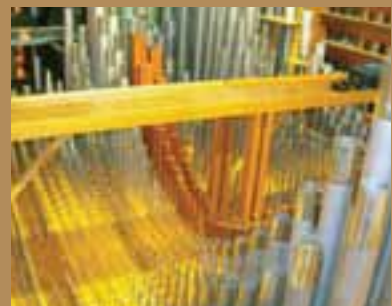
The organ pipes were cleaned, retuned, and reinstalled. The largest pipes (left) are made of wood and were too large to remove. The pipes were regilded.

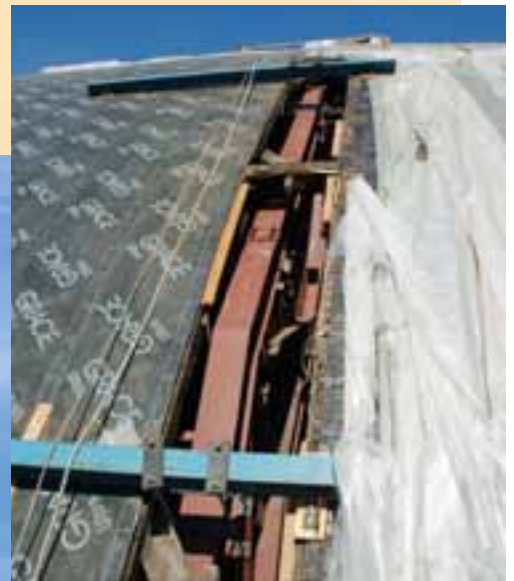
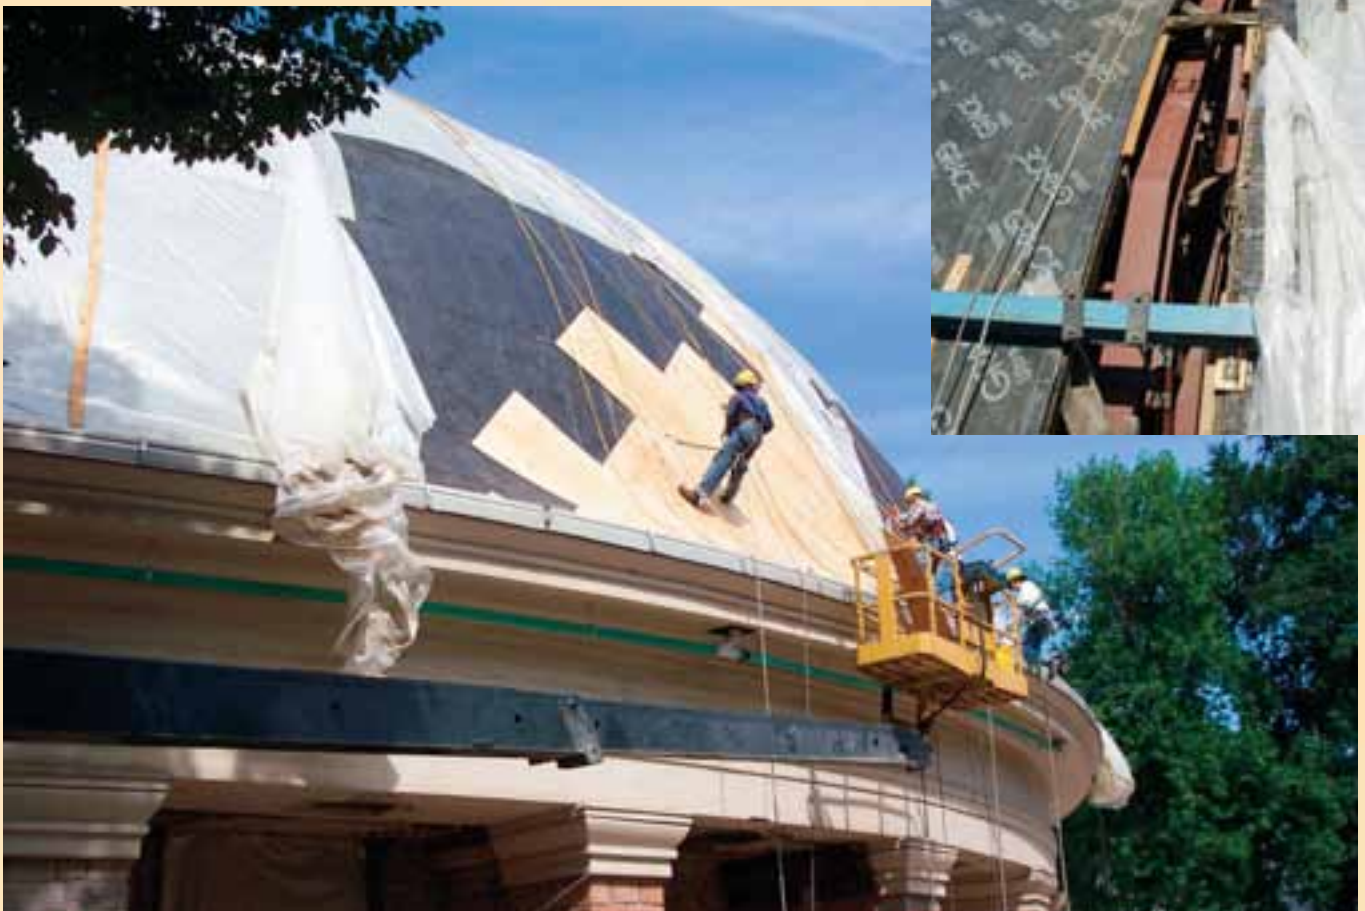
The new aluminum roof, shown here in December 2005. Below: On each end of the Tabernade, a wide steel truss—called a “sister truss”—was attached to the existing wooden truss to strengthen it. Below left: Workers apply plywood prior to adding the new roof. ■
