Renovating the Tab

While the Salt Lake Tabernacle was closed to the public for two years, workers carried out an extensive renovation on the 140-year-old building.

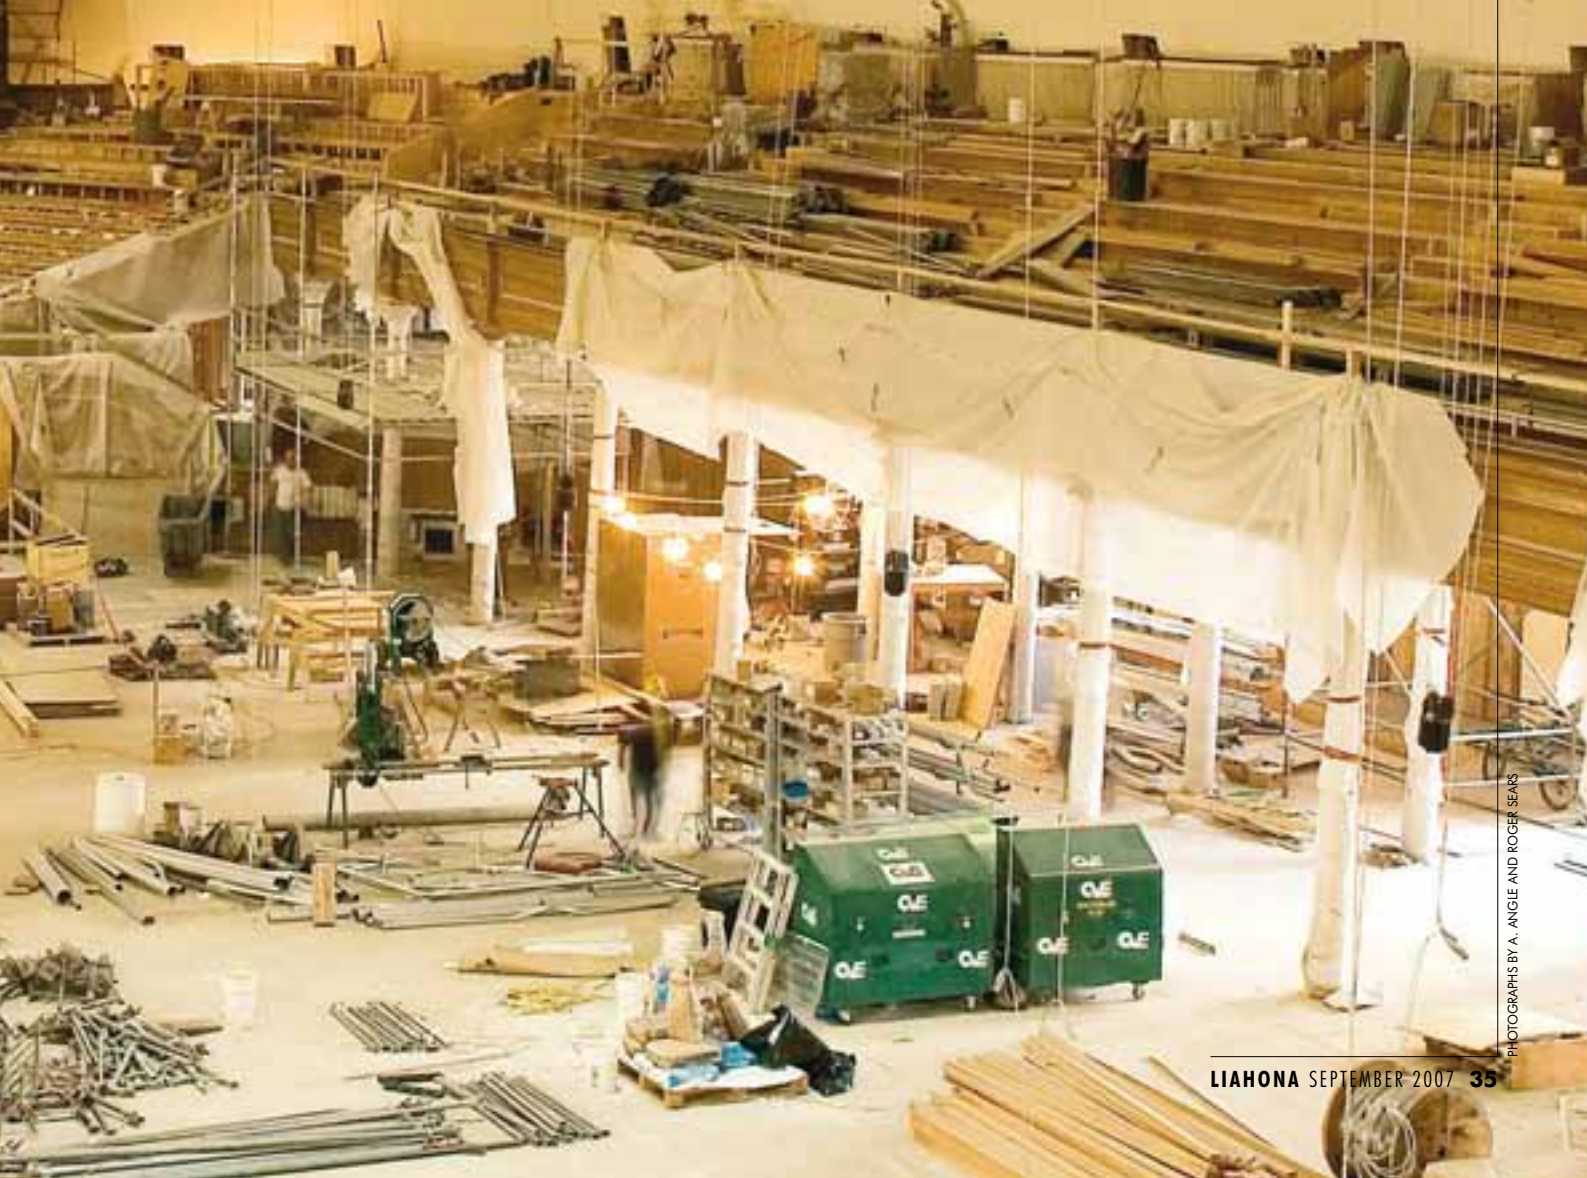
By June 2006 all of the pipes of the organ except those seen here had been removed for cleaning, and the slope of the floor in the balcony was being increased so all visitors would have a good view of the rostrum. The floor had been covered and the pillars wrapped for protection. The restoration of the ceiling had been finished.

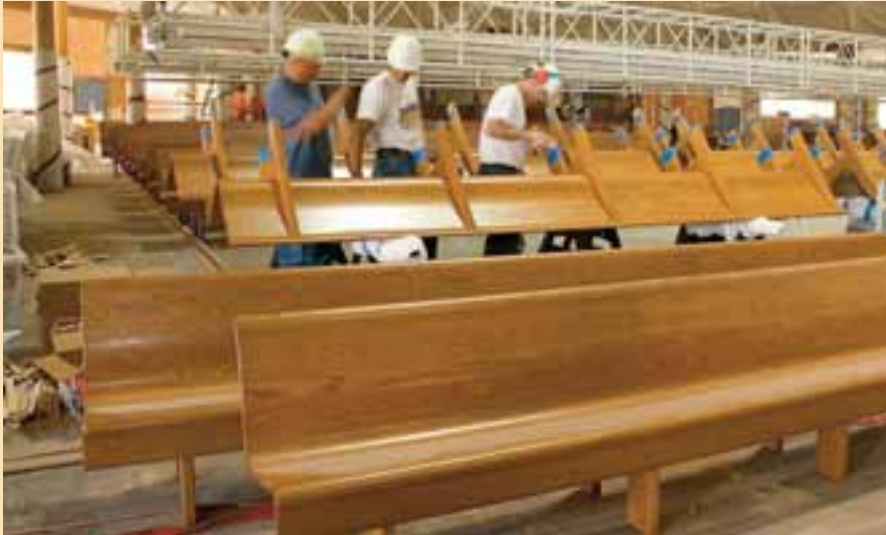
Above: Workers install solid white oak pews, which will replace most of the original soft pine ones. The original pews, painted by pioneer artisans to look like oak, were damaged and worn. Some will be permanently displayed.

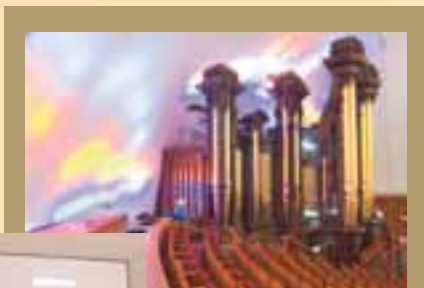
Audiovisual upgrades include a variety of new lighting effects. The inset shows one of two screens mounted on either side of the organ pipes. When not needed, the screens can be retracted behind the choir seats. State-of-the-art audio equipment has been installed, yet the famous acoustical properties of the Tabernacle have been preserved.

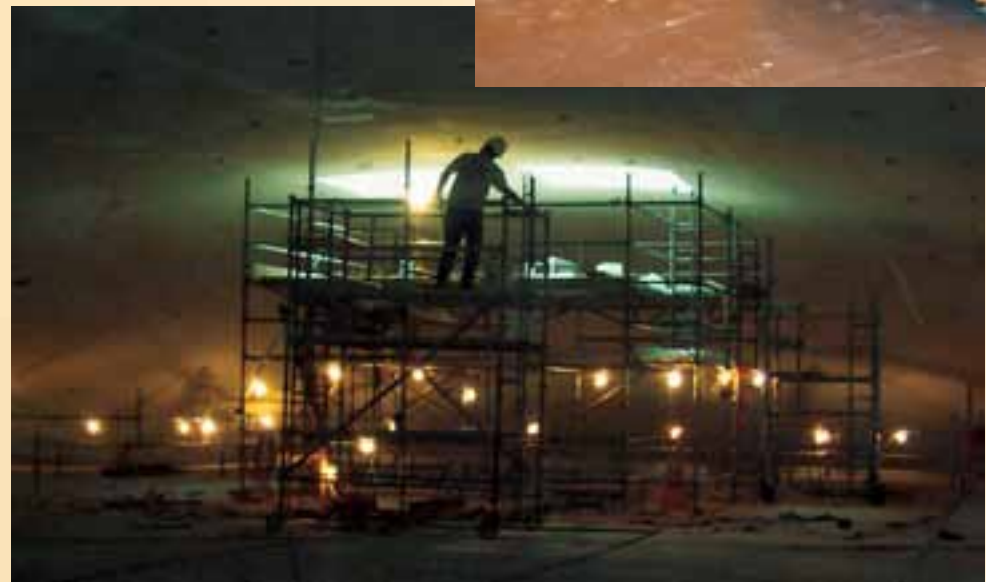
A worker stands atop scaffolding that is several stories high as he works on the restoration of the ceiling. Fourteen layers of paint were removed to reach the original plaster. After repairs were made, workers applied plaster that matched the properties of the historic plaster in both its content and acoustic properties. Care was taken to preserve the waviness of the original ceiling.

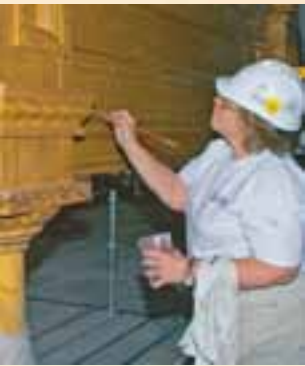
A skilled artist touches up the faux finish on the face of the balcony. Most of the faux graining on the walls and pillars of the Tabernacle needed to be repaired or replaced.

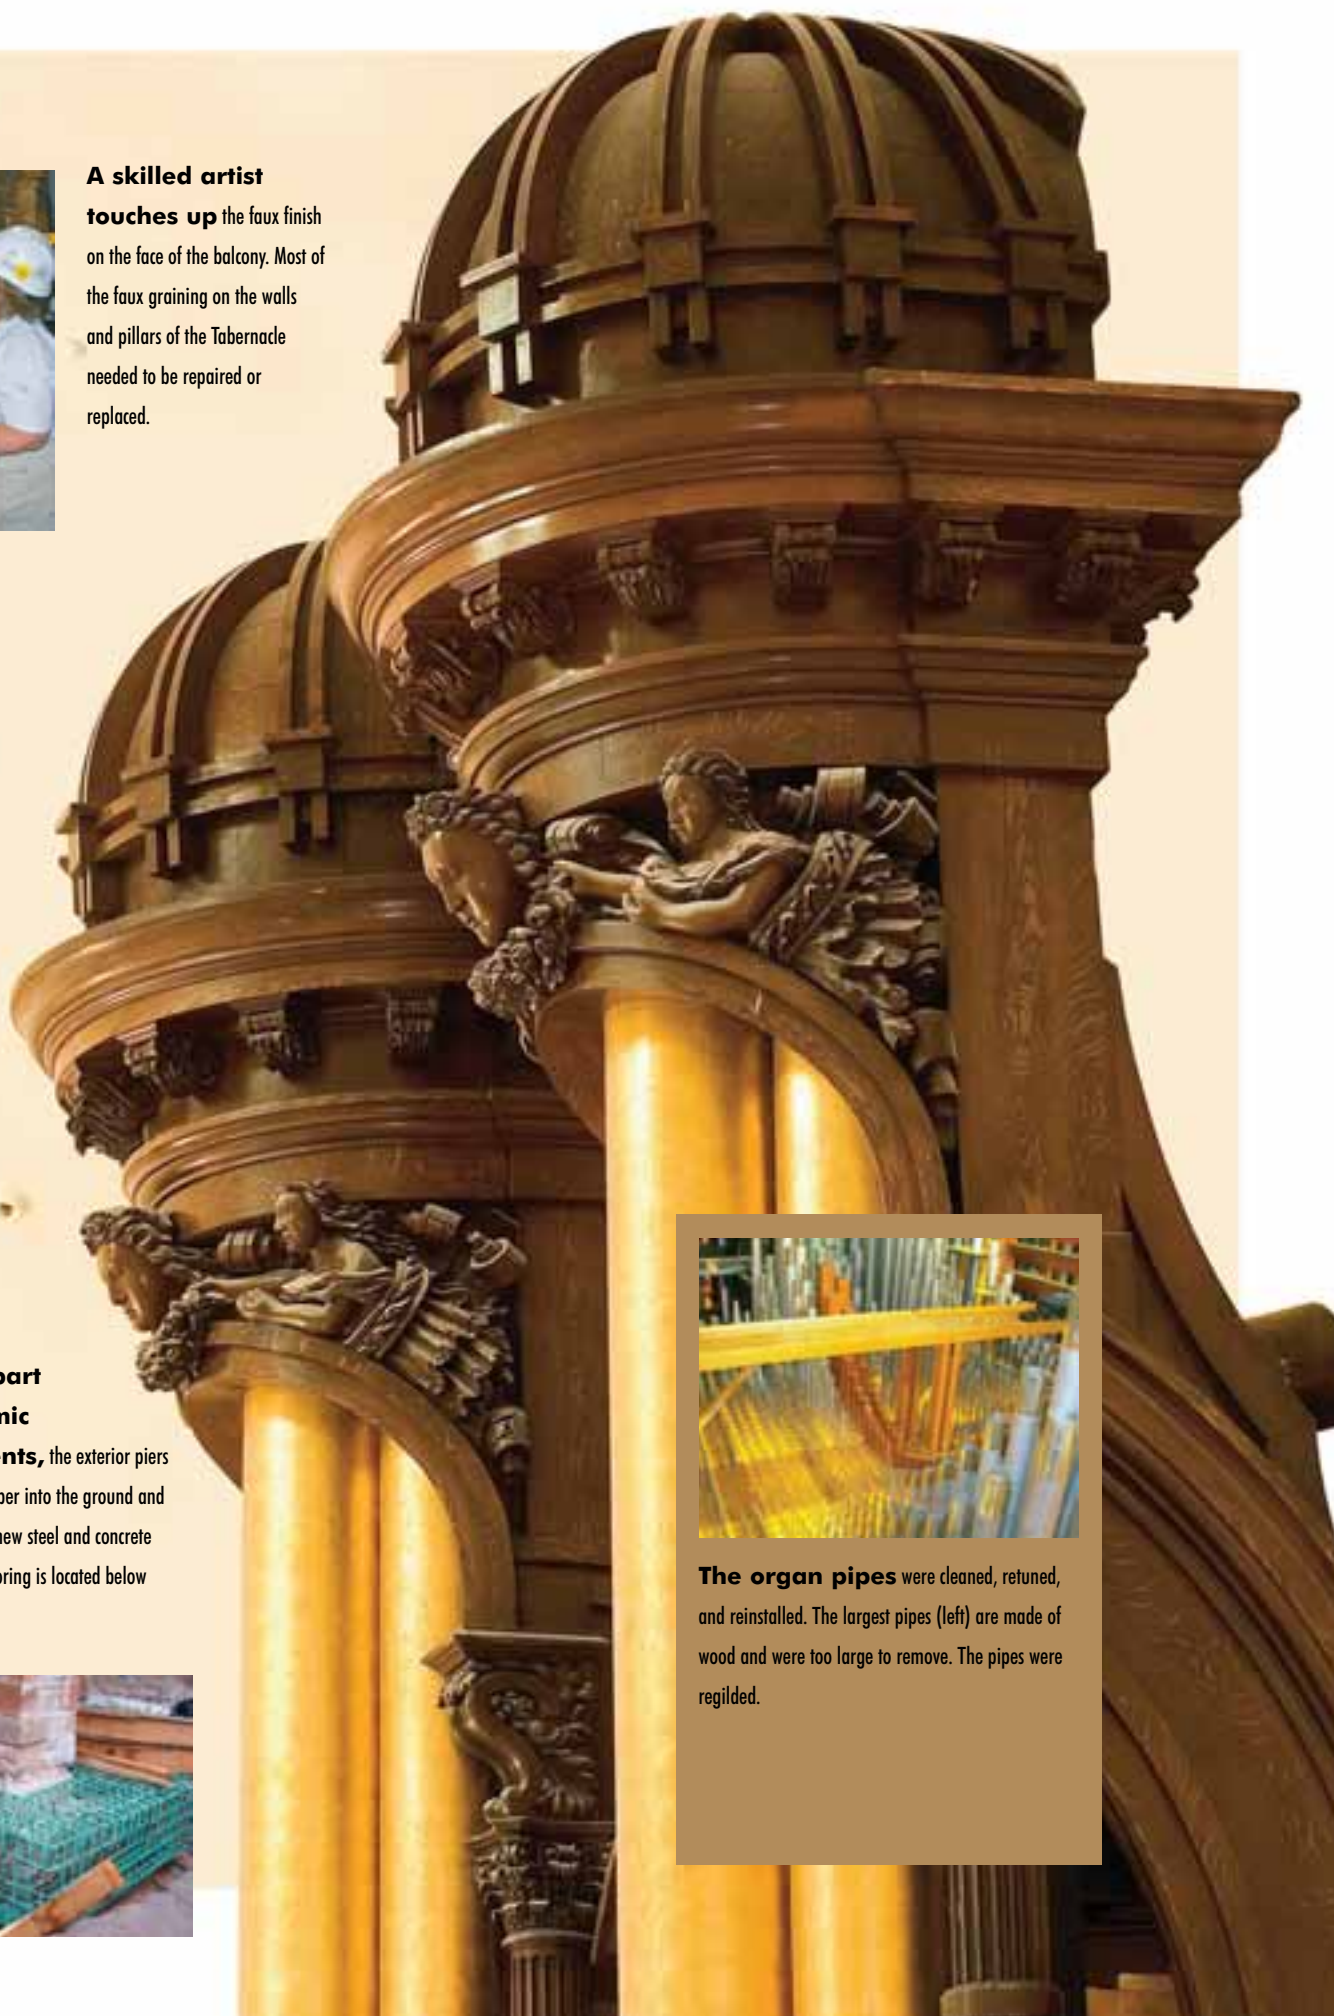
The organ pipes were cleaned, retuned, and reinstalled. The largest pipes (left) are made of wood and were too large to remove. The pipes were regilded.

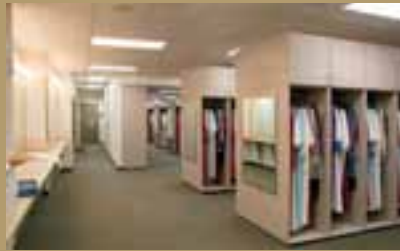
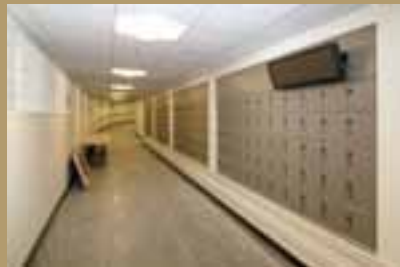
Significant space under the Tabernade has been remodeled. Right top: The administrative offices of the Tabernade Choir and Orchestra at Temple Square now occupy the space previously occupied by the baptistry. Center: The women's changing room provides each choir member with her own cubicle to store her permanent wardrobe. The men have a similar space. Bottom: The music library houses all of the choir's sheet music. It also provides individual lockers for each of the approximately 350 choir members. Librarians compile binders containing the right music in the right part for a given show and place them in the individual lockers.

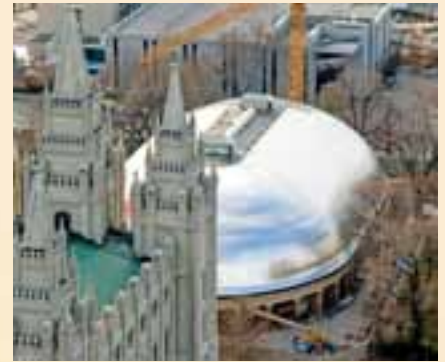
The new aluminum roof, shown here in December 2005. Below: On each end of the Tabernade, a wide steel truss—called a “sister truss”—was attached to the existing wooden truss to strengthen it. Below left: Workers apply plywood prior to adding the new roof.
